Subject: Existing Structure Assessment Results – Main St. Bridge, Central City**Project No.: 22039****Prepared by: Courtney Wand**

Existing Structure Assessment Results

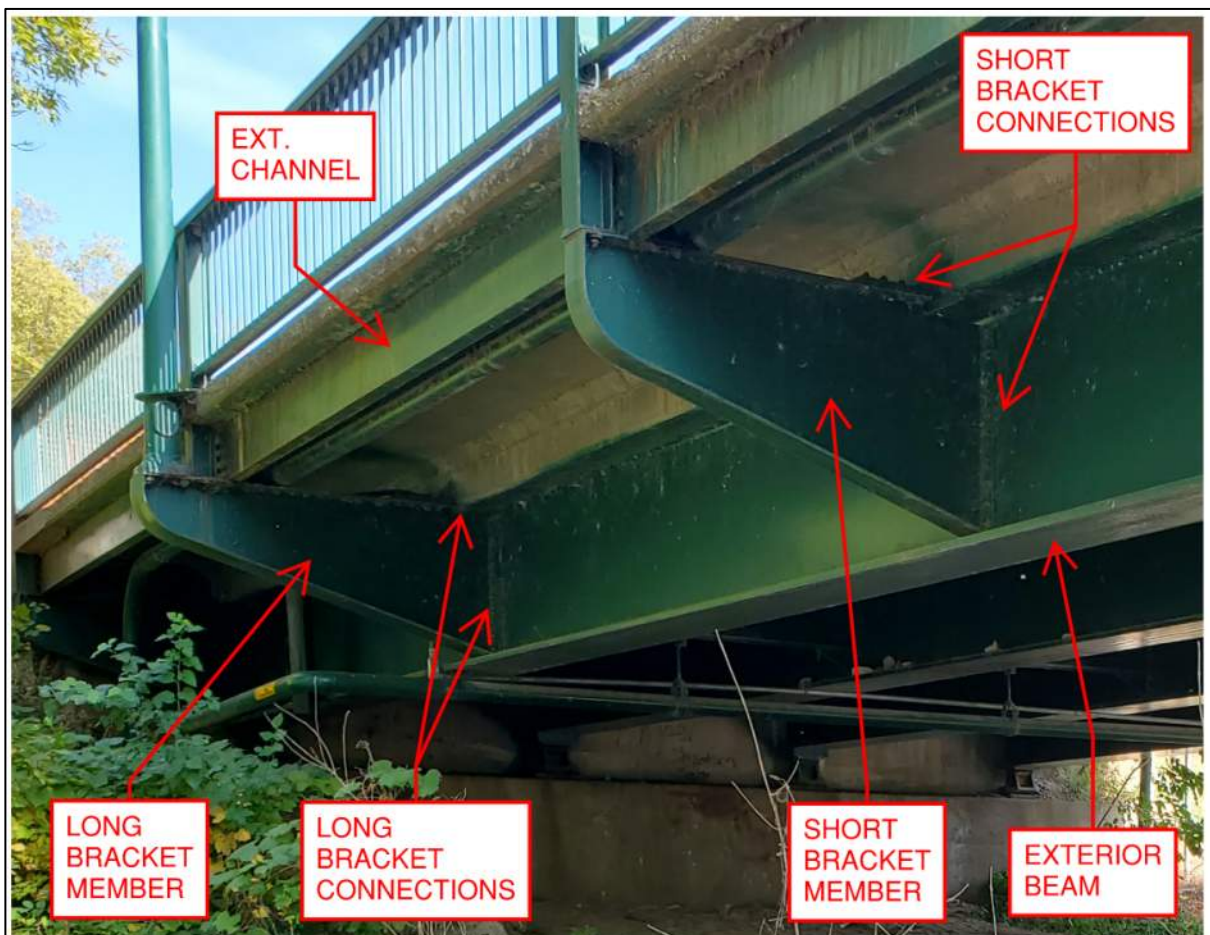
Figure 1 - Analysis Locations

An in-office evaluation of the structural components supporting the sidewalk slabs was completed. It was determined that the existing steel brackets, bolted connections, and edge channels generally have adequate capacity to support a new sidewalk slab. Summary Table 1 of each component's load to capacity ratio is included below. A ratio of 1.0 indicates that the member is exactly as strong as required to support the anticipated loading. Ratios less than 1.0 indicate that the component has reserve strength. Figure 1 depicting each analyzed location is also below.

As noted in the table, the exterior beam does not have appreciable reserve capacity (ratio=0.995). As a result, it is not recommended that the sidewalk be widened to create a 5'x5' ADA turning space because adding additional load to the exterior beams would result in the bridge having less than the full legal load capacity for all of the Iowa DOT's required vehicles. Therefore, it is not possible to create the 5'x5' turning space on the bridge without needing to restrict legal traffic on the roadway portion which would be detrimental to the bridge's use, or without modifying the exterior beams, which is not included in the current project scope. Please retain this summary document in the project's file.

Component	Ratio of Load/Capacity	Notes
Exterior channel	0.58	15% general reduction in capacity due to observed condition
Short (without Light Pole) Bracket Member	0.24	5% general reduction in capacity due to observed condition
Short Bracket Bolted Connections	0.89	Based on member strength versus actual loads. Does not include reductions for missing hardware, corrosion.
Long (with Light Pole) Bracket	0.18	5% general reduction in capacity due to observed condition
Long Bracket Bolted Connections	0.58	Based on member strength versus actual loads. Does not include reductions for missing hardware, corrosion.
Exterior Beam	0.995*	No reductions taken due to beam condition. *Additional analysis of splice plate required.

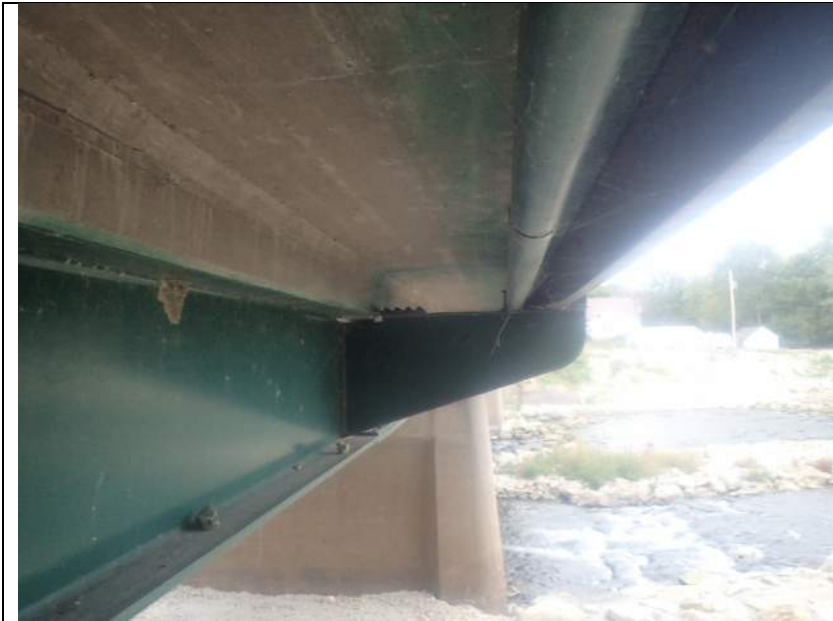
Underside
of sidewalk
slab

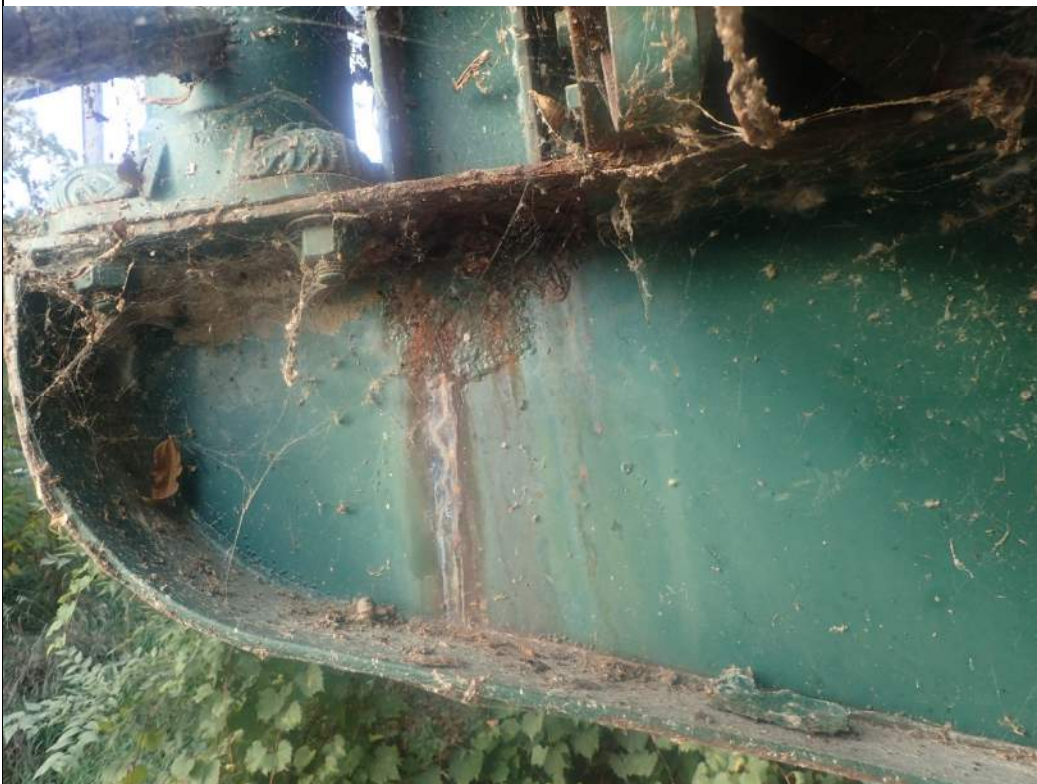
Long
bracket,
corrosion
of rail post
connection
and top
plate of
bracket.
Blistering of
bracket
web.

- Failure of multiple light poles necessitates replacement.
- > **Repair or replace select locations of the sidewalk brackets.**
 - Primarily the top plate of the brackets was noted to have the most corrosion and section loss near railing connections. Repair or replace the most severe sections.

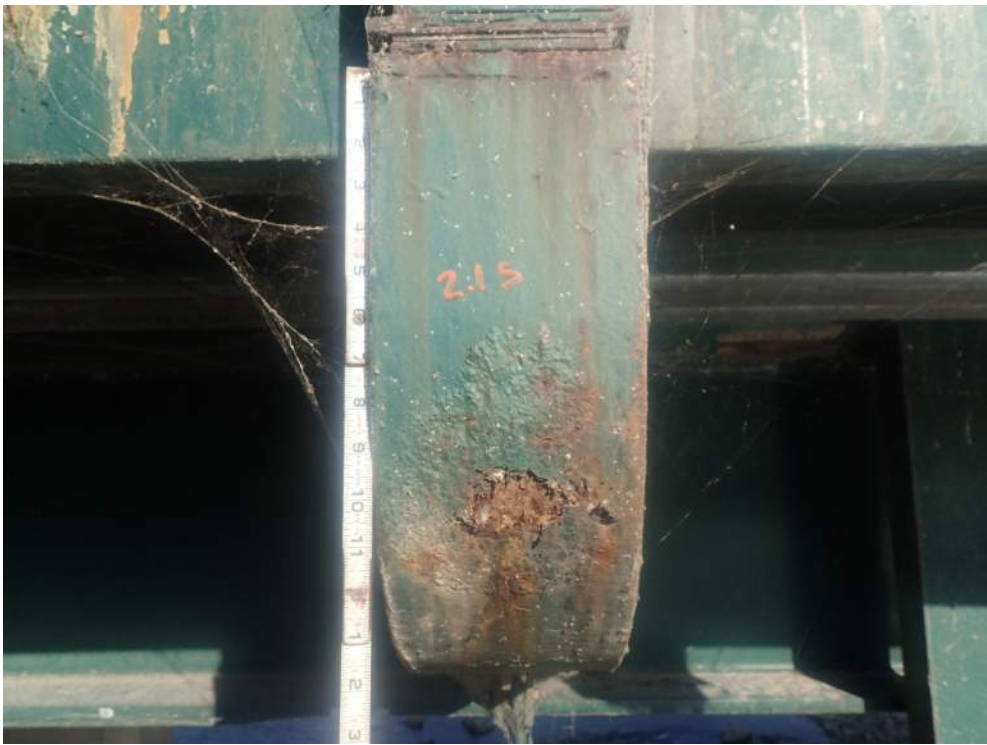
<p>End of short bracket plate</p>

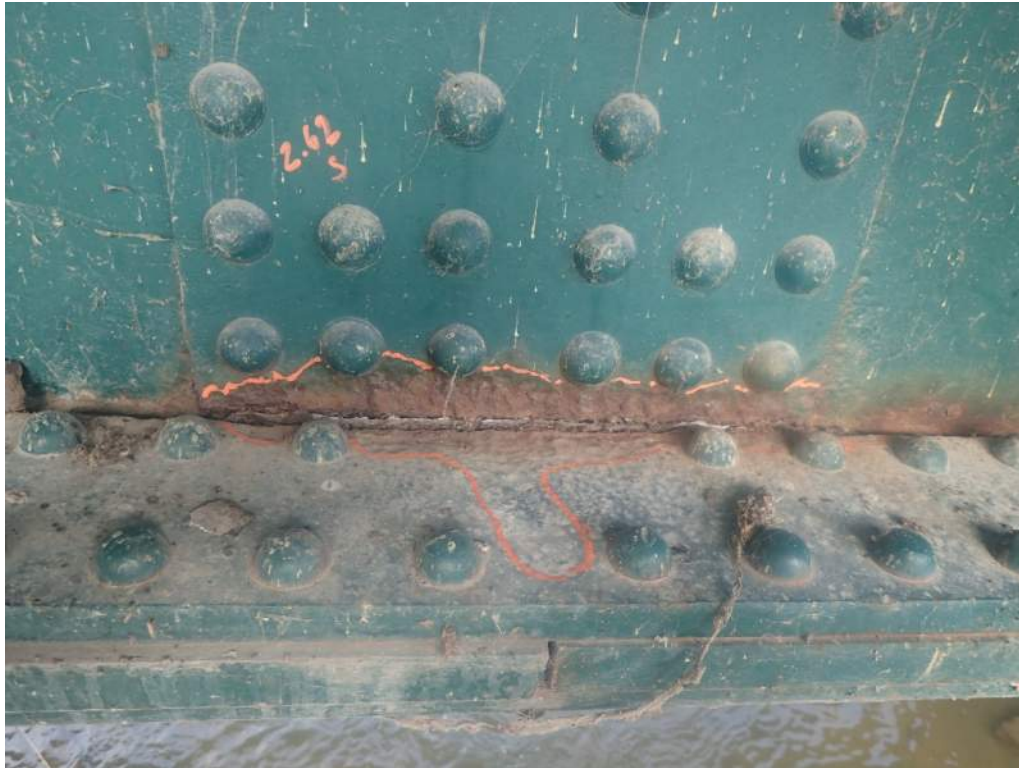
Closeup of exterior beam splice plate corrosion and section loss

- > **Calculate impact to bridge capacity of the corroded splice plates on the exterior beam.**
 - Recommendation will depend on the required strength versus actual strength remaining.

- > **Evaluate the corroded exterior beam splice plates.**
- > **Prepare estimate of probable construction costs for the additional work in the Recommendations.**
- > **Compare the estimates of probable construction costs for the 3 original alternatives with the updated Alternate 1 costs.**
- > **Meeting to review Alternative costs and confirm scope.**
- > **Field topographic survey to establish sidewalk tie-in points.**
- > **Final Design Development**

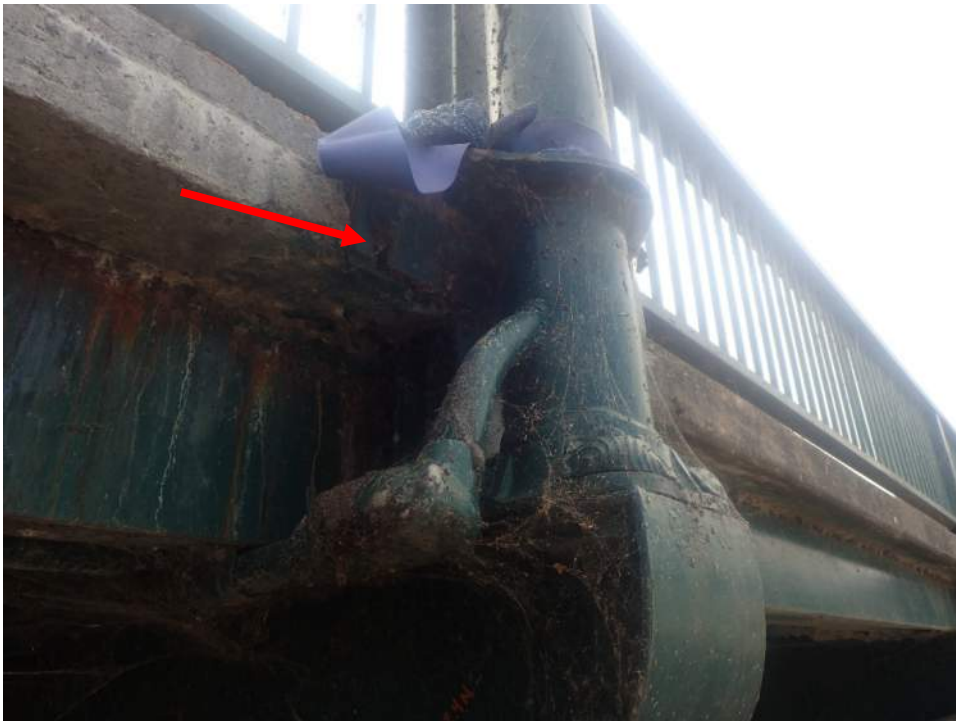
Light pole strapped to railing. Split connection plates.

- > **Remove and reinstall the existing steel railing. Replace light poles.**
 - Once removed from bridge, repair or replace damaged or corroded bases and connections from existing railings.
